Arlington Conservation Commission

Notice of Intent: 1 Cross Street

RE: 1 Cross Street – NOI Stormwater Mitigation Comments

1 CROSS STREET
SITE DETAILS
LOCATED IN
ARLINGTON, MASSACHUSETTS
PREPARED FOR
TIMOTHY KRESL

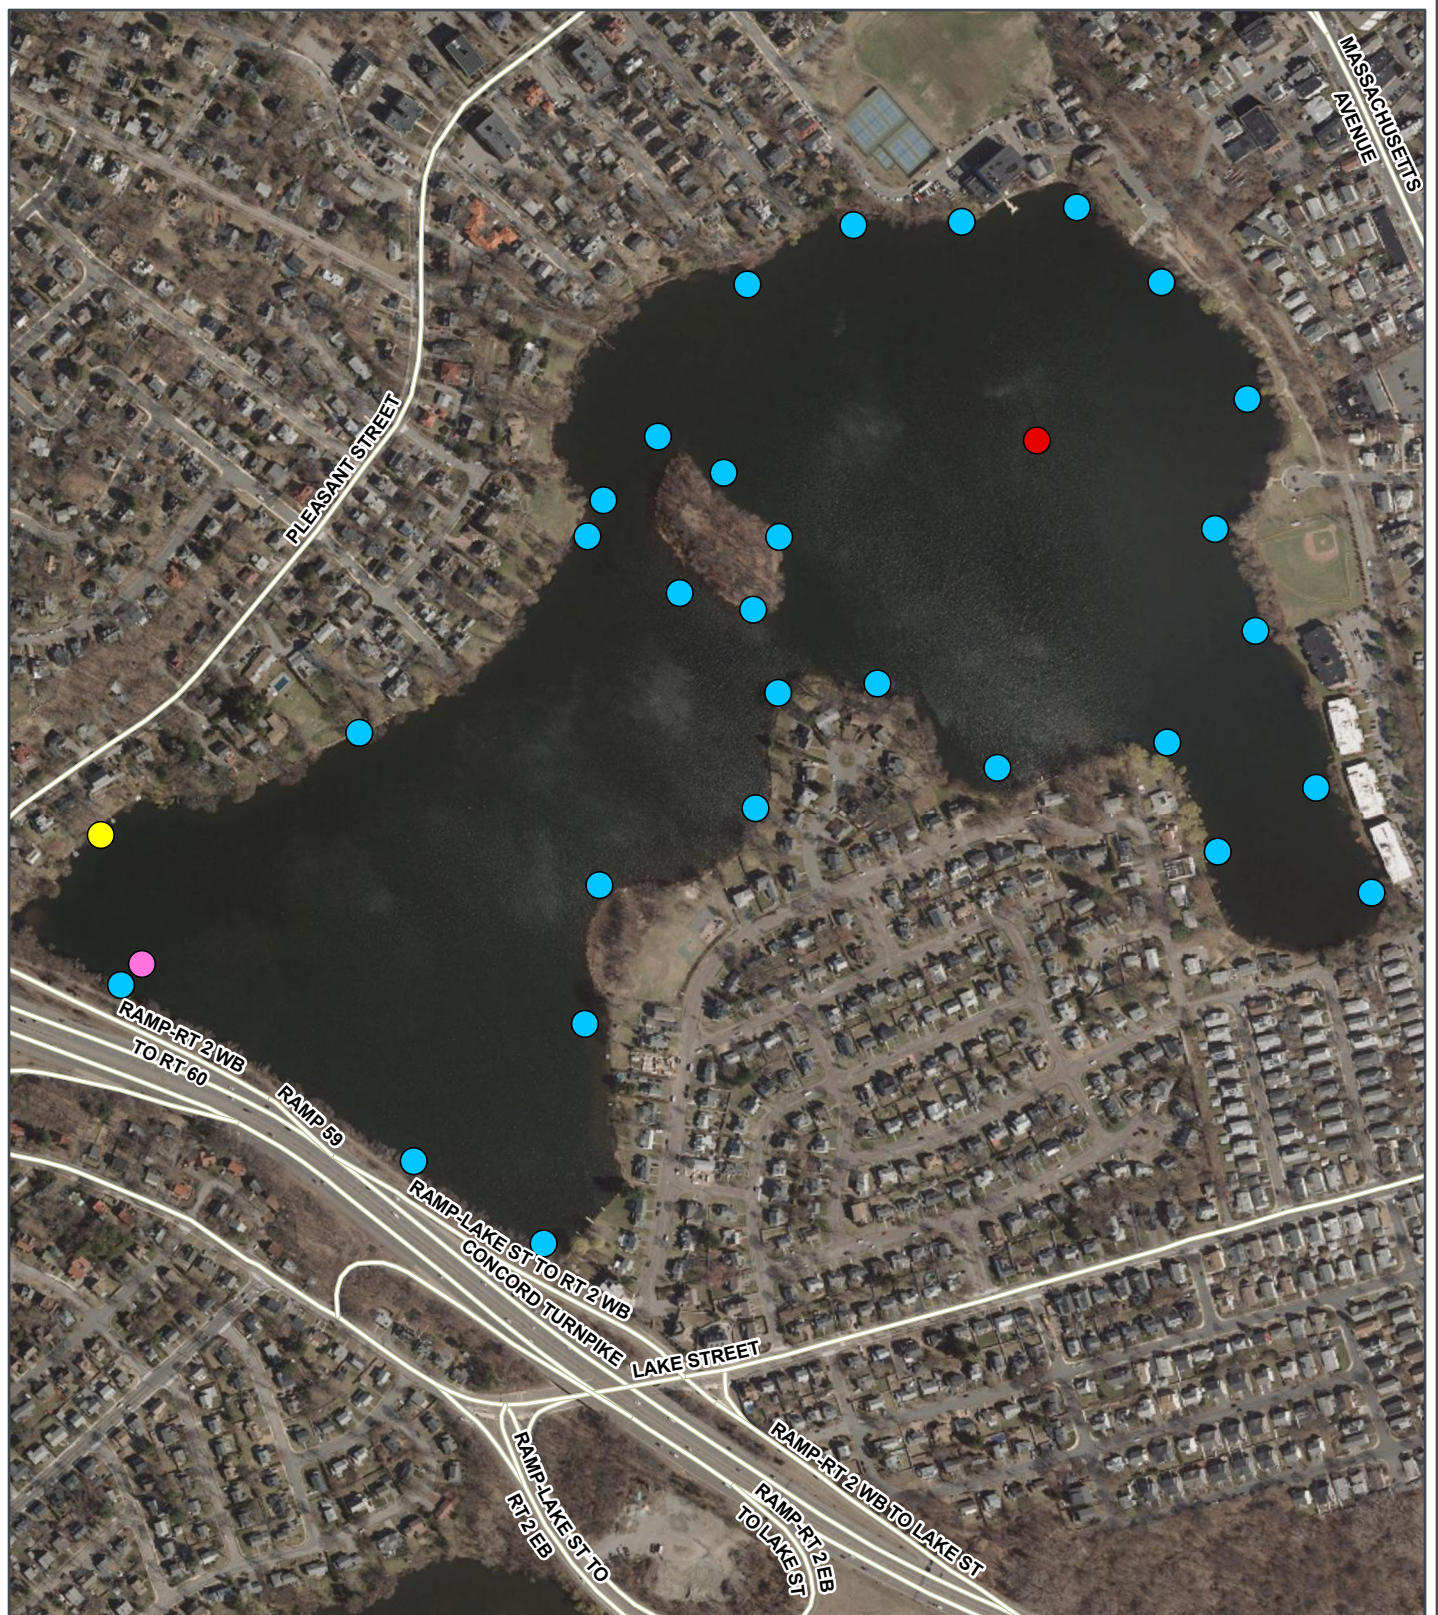
Figure 1

Figure 1. Sampling

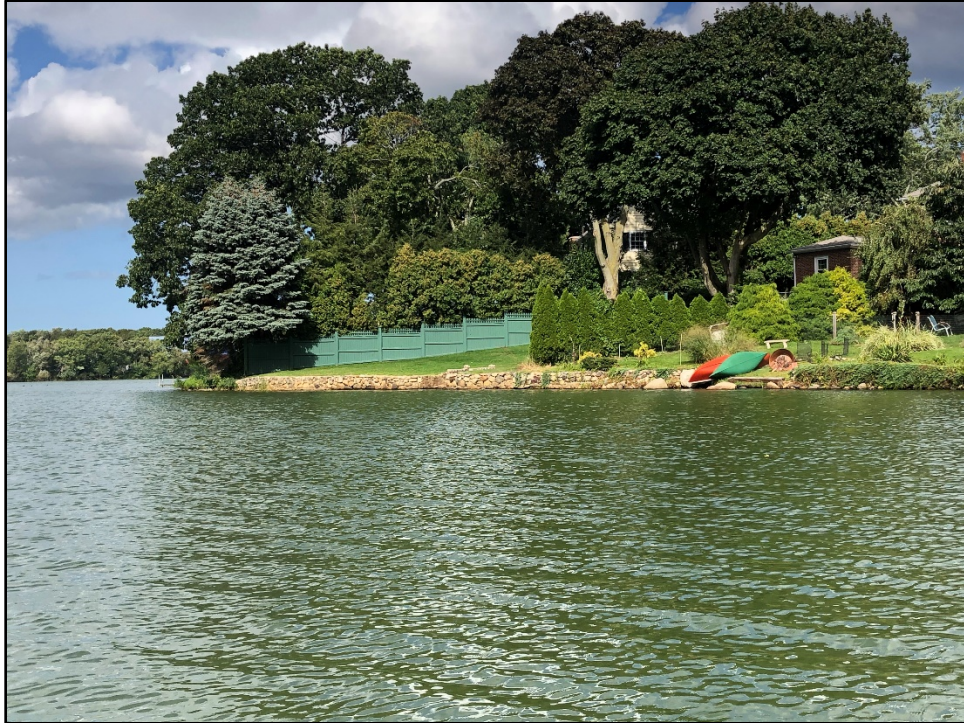
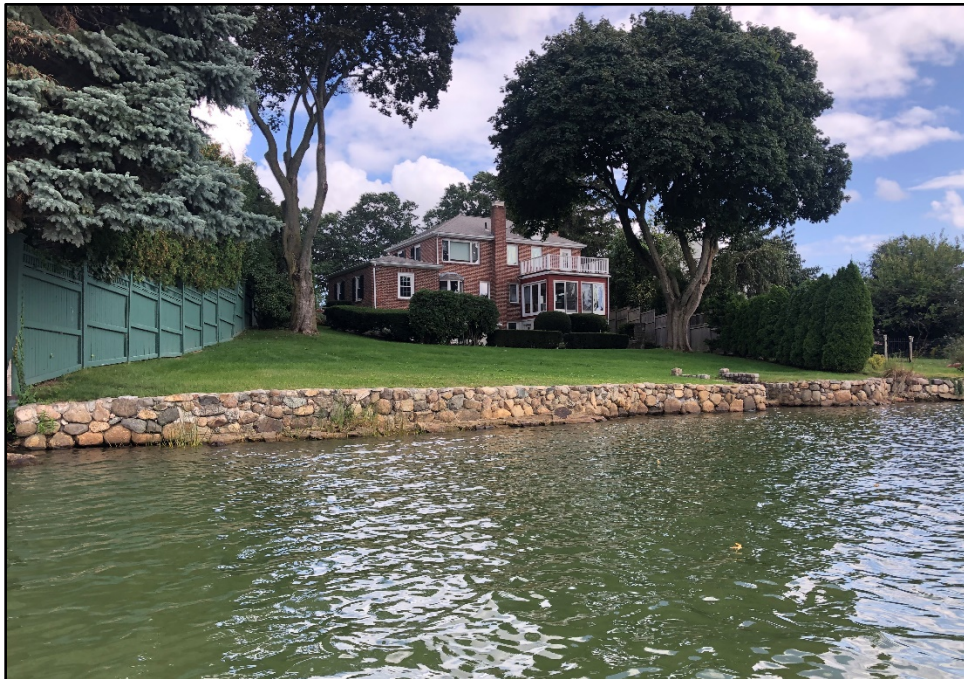
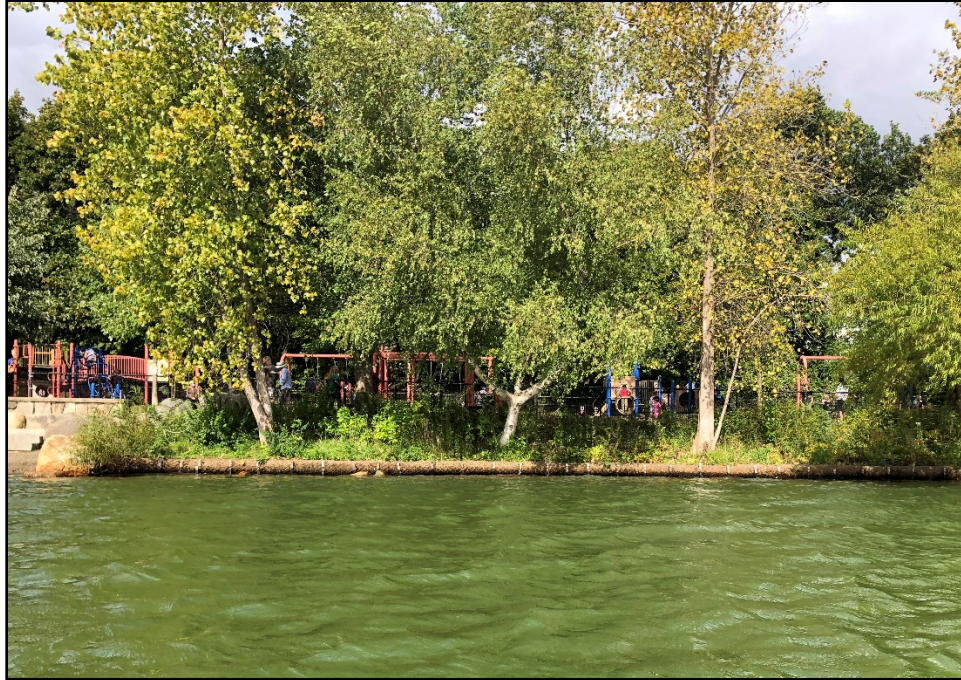
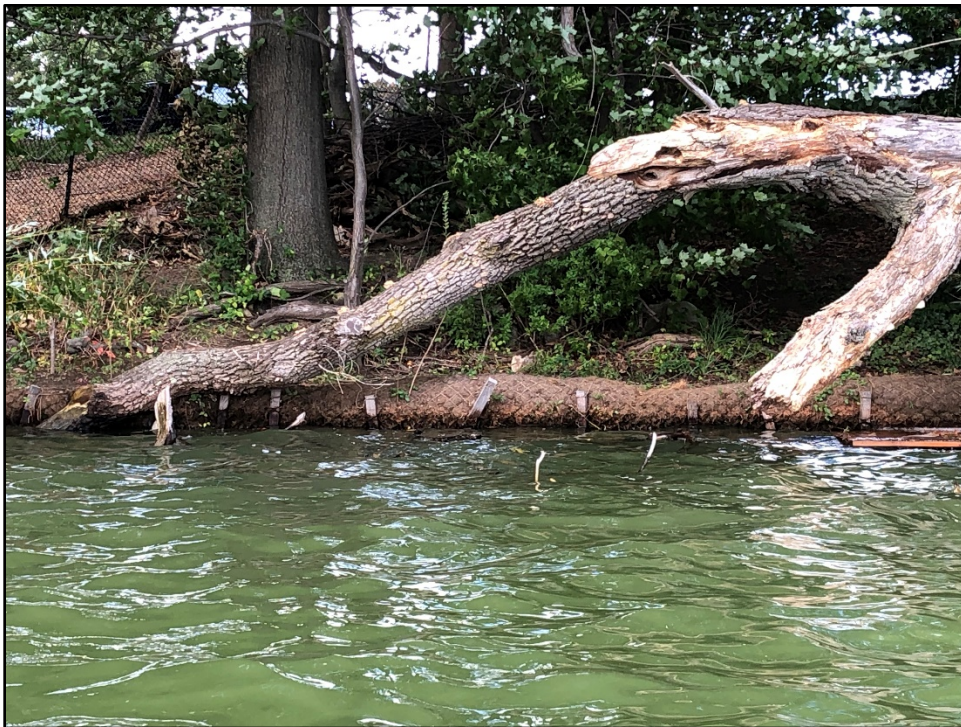
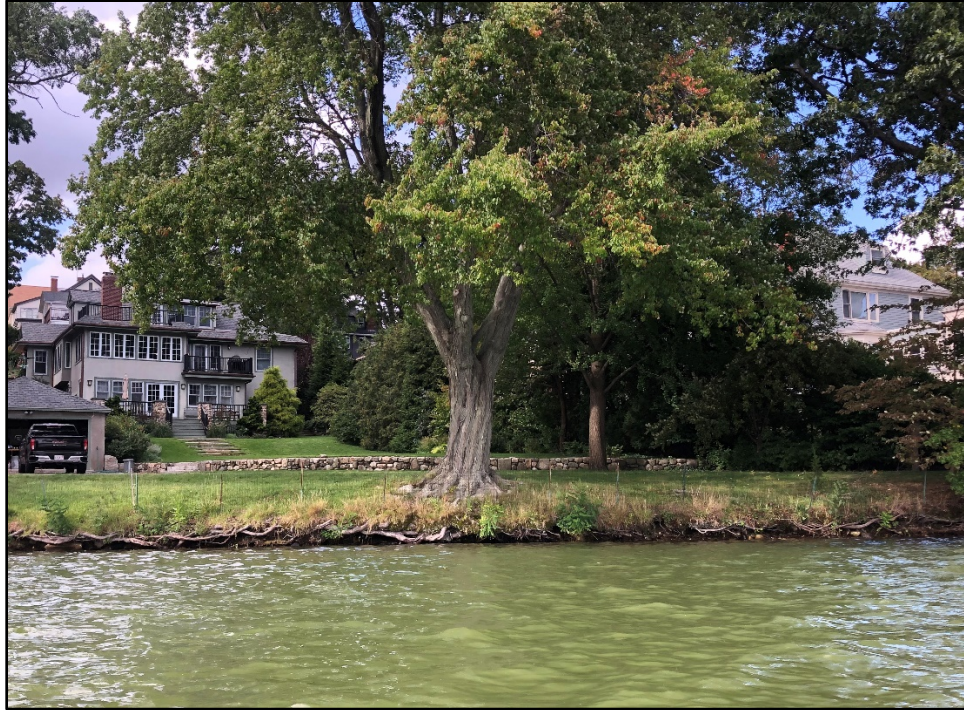
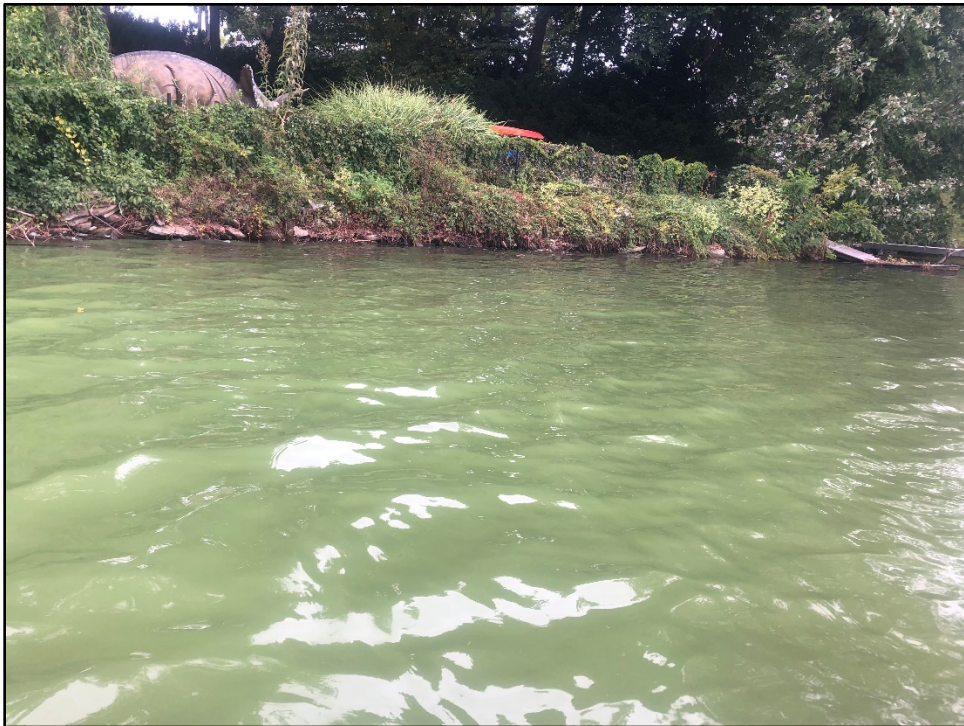
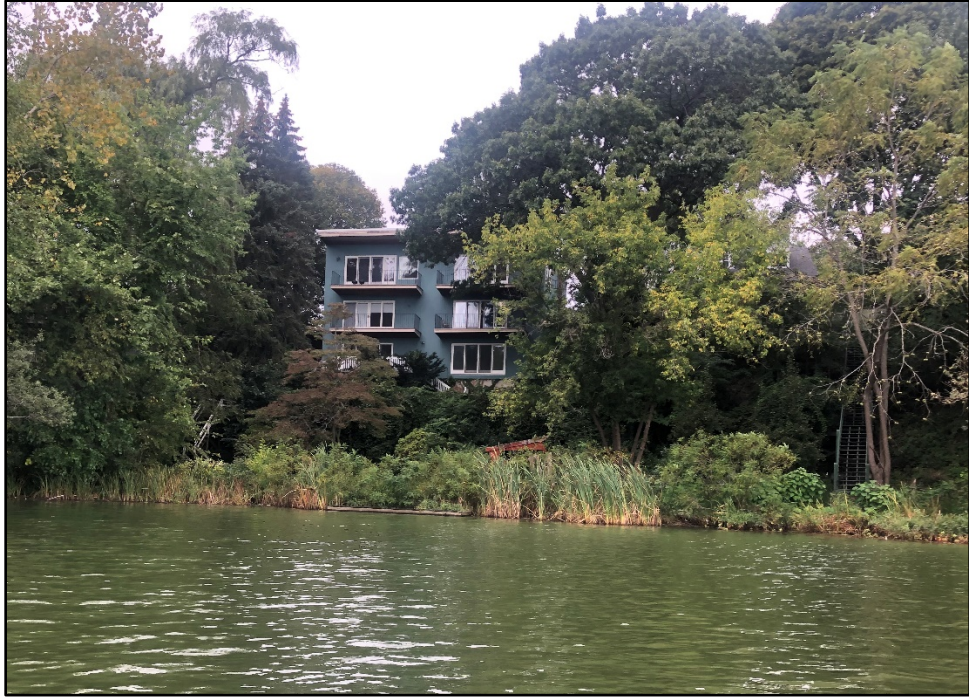
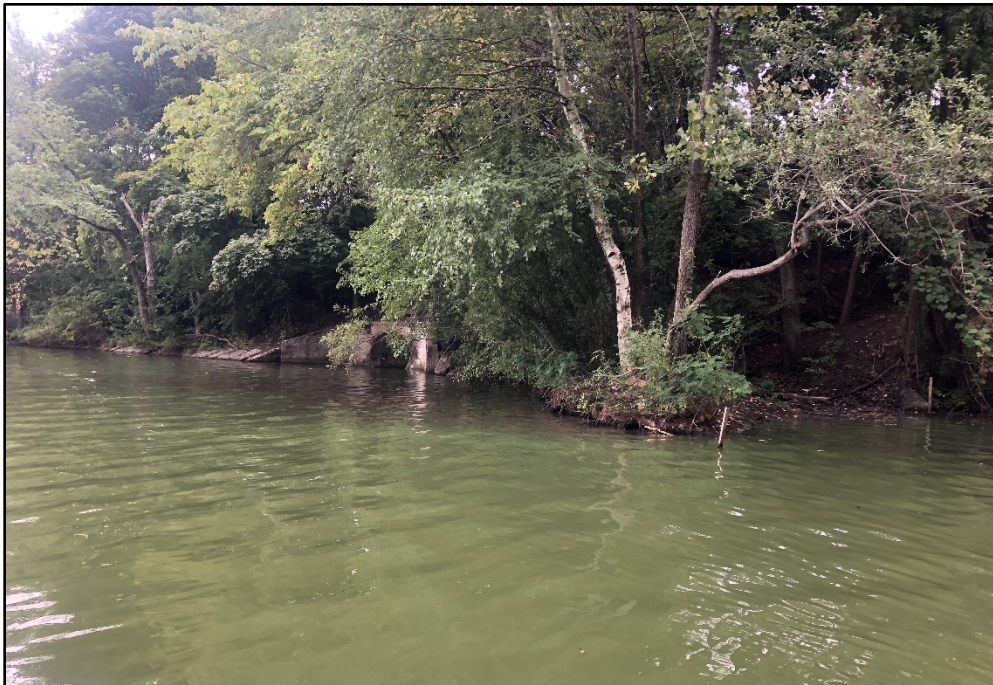
Photo Pages

Property owners around the pond have installed bank stabilization measures (stone armoring and coir log installation) in past years. These measures were observed in various states of stability and effectiveness during SWCA's survey. Many areas where stone have been installed are in good shape; however, there are large stretches of mown lawn that extend up to the top of the stone. This means that any nutrients or contaminants within or applied to the top of the lawn surface run directly into Spy Pond during storm events. The primary issue with highly manicured lawns up against pond banks is that there is almost no above-ground vegetation to slow the velocity of water, fines, and any particulates held within either

The sections of coir logs that have been installed appear to be stable in all locations noted during SWCA's survey. However, most coir logs do not appear to be vegetated. This is fairly common because coir logs are very densely packed with coconut fiber. Some practitioners will attempt to aid the process of vegetation by punching holes in the coir logs and installing small, quick-growing shrubs (willows, dogwoods, etc.). Even this is not always extremely effective though, due to the density of the log surrounding each hole. The setting in which coir logs are most effective is when they are periodically inundated with water and/or washed over by nutrient-rich sediments. This allows sediment to fill in the coir logs as the coconut fiber compresses and/or decays. Vegetation can then more easily establish on the surface. The hope is that the roots of early established vegetation within or nearby the coir logs will fill in the space in which the coir log was originally installed. If vegetation does not establish, the section of the bank in which the coir log was installed will be left with an unvegetated and vulnerable hole once it fully decays or is dislodged. Therefore, regular maintenance of coir logs is very important to the long-term efficacy of this type of bank restoration. Additional soil and seed or containerized plant material can be added to help the natural process of revegetation in areas where coir logs have been installed.

There are also sections of the bank around the pond that are showing signs of erosion. Photo D-6 (Attachment D) is an example of the most common type of bank erosion noted during the September 2021 survey. The bank is more or less unvegetated aside from lawn and trimmed herbaceous material. There is a large tree growing right on the bank, the roots of which extend laterally along the bank for stability. However, it appears that the flow of water against the short (but abruptly steep) bank has begun to undercut the roots. The roots are now exposed and there is a section of the mid to lower bank that is unstable and will continue to erode if no action is taken. The sediments from the bank will continue to settle into the pond and increase the build-up of sediments (potentially nutrient-laden) within the pond.

One traditional approach to water quality improvement through ecological restoration is bank restoration. As banks degrade, they deposit sediment and vegetation into the pond, furthering nutrient loading, sediment accretion, and eutrophication. Furthermore, a degraded bank will not function to buffer the pond from contaminant and nutrient additions during large storm events. As described in Section 4 of this report, there have been several bank restoration projects around Spy Pond. Maintenance and regular inspections of these areas should continue to ensure their stability and efficacy. There are also sections of the bank around the pond that are well stabilized and should be considered suitable reference areas for future bank restoration and improvement projects. These areas include stable in-water and emergent vegetation (wetland plants that can withstand both prolonged inundation and periodic dry conditions), as well as layers of herbaceous and woody wetland vegetation up-gradient from the emergent shelf. Restored banks should be fully vegetated and consist of a gradual incline to upland elevation. New bank restoration projects should be focused on areas of degraded or undercut bank faces and stormwater input areas (catch basin outflows, culverts, sections of channelized flow) should be prioritized for restoration. Installing an emergent shelf and wetland vegetation that has a high propensity for nutrient uptake will help reduce the continued input of nutrients in these stormwater inlet areas.
